CARDINAL

December 5, 2019

RE: Rogers Road Bridge Inspection

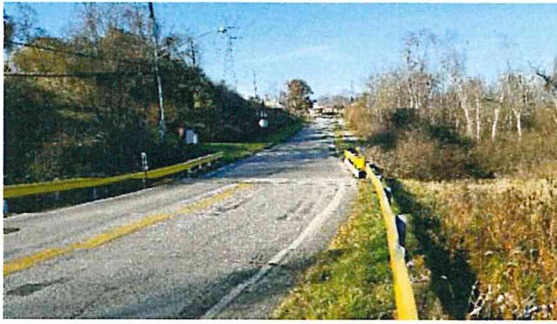
Road Condition: The asphalt surface on both approaches to the bridge is aging and showing reflective cracking from the original concrete pavement below. While the pavement is nearing the end of its functional life, it does not appear to be showing signs of potholing or base failure in the area of the bridge. A transverse crack and "dip" are noticeable at the transition between the roadway and the bridge, but this is characteristic of typical age-related settlement at the abutment, and is not a cause for major concern at this time. Guardrail is freshly painted (addressing a concern raised by KYTC in the 2018 report). Some shoulder erosion is present at the wingwalls. Recommend further monitoring for signs of pavement undermining.

Exhibit 1: Rogers Rd. westbound approach

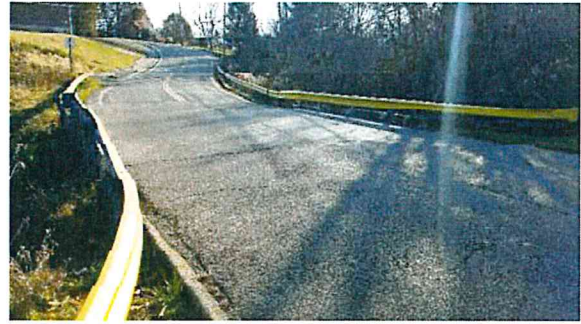
Exhibit 2: Rogers Rd. eastbound approach

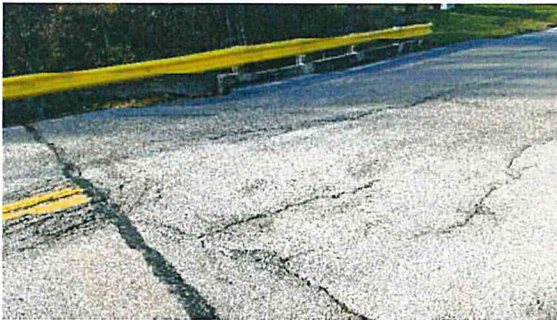
Exhibit 3: Pavement sag at abutment

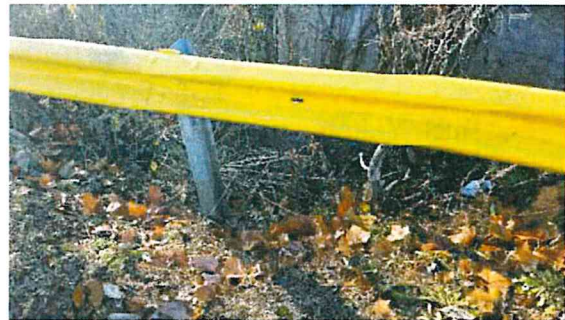
Exhibit 4: Shoulder erosion at wingwall

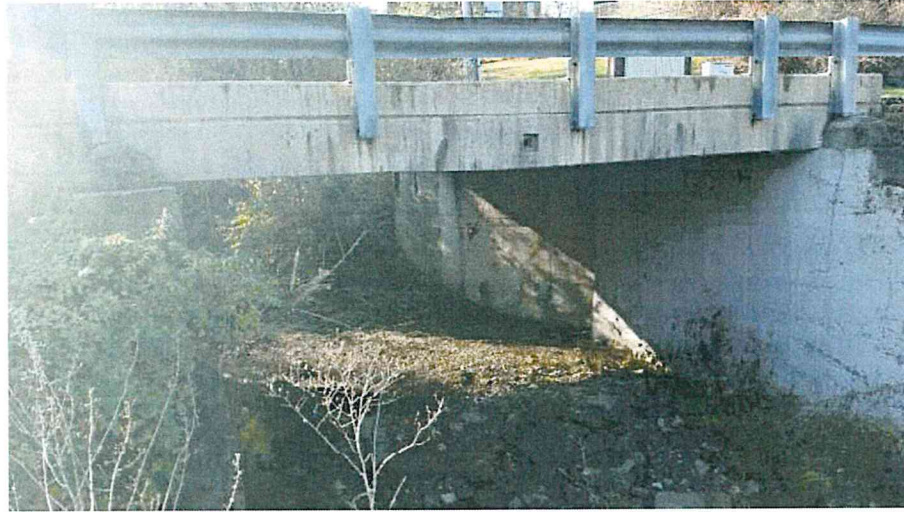
Exhibit 5: Bridge span (viewed from north side)

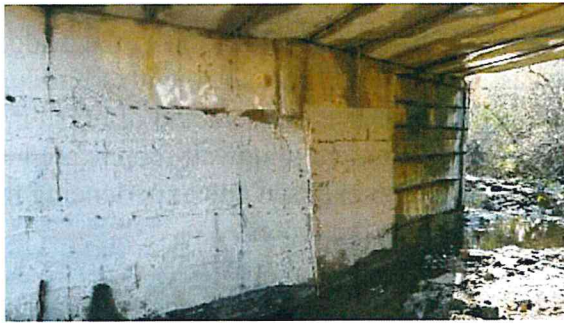
Abutments/Wingwalls: The concrete abutments on both sides of the bridge are showing signs of age-related deterioration: surface scaling, mineral/rust staining, and cracking. Honeycombing is present at areas where the concrete was insufficiently consolidated at time of construction. Previous repairs are visible on both sides. The two sides of the western abutment have shifted and exposed rebar is present at the joint; the joint has been previously filled and the movement does not appear to be recent. Reinforcing bolts and grout/paint sealing are present along the eastern abutment, and the southeast corner of the wingwall has a large vertical crack that has been reinforced with a series of metal bands. All bands appear to be firmly attached and performing adequately at the time of inspection. No additional reinforcement is recommended at this time.

Exhibit 6: East side abutment
(Note metal banding, bolts, and grout/paint)

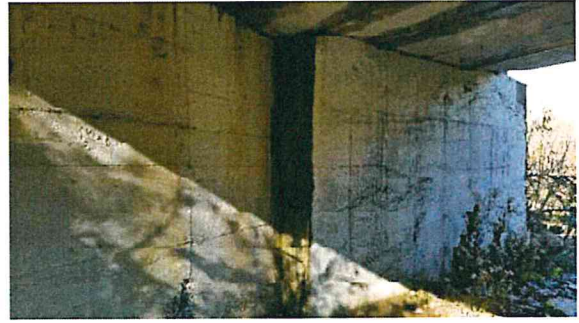
Exhibit 7: West side abutment
(Note abutment offset and honeycombing)

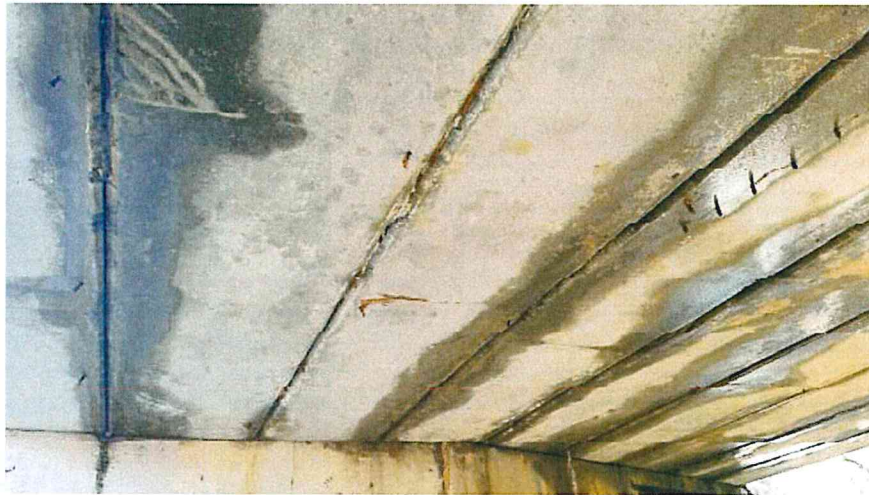
Bridge Deck: The underside of the bridge deck is experiencing some minor (cosmetic) cracking. One longitudinal crack is present and has been previously treated with epoxy injection. Other epoxy injection tubes were noted at seemingly random locations around the bottom of the deck, and did not appear to be related to any cracking or other damage. Active seepage was present along the longitudinal joints of the deck, most likely due to the recent rainfall infiltrating pavement cracks and draining through the deck. This seepage does not appear to be resulting in any external structural deficiency.

Exhibit 8: Bridge deck and seepage
(Crack and epoxy injection tubes present at upper right corner of photo)
