Assessment Report
May 18, 2019

Crescent-Villa Fire Authority

Crescent Springs, KY

FACILITY CONDITION ASSESSMENT

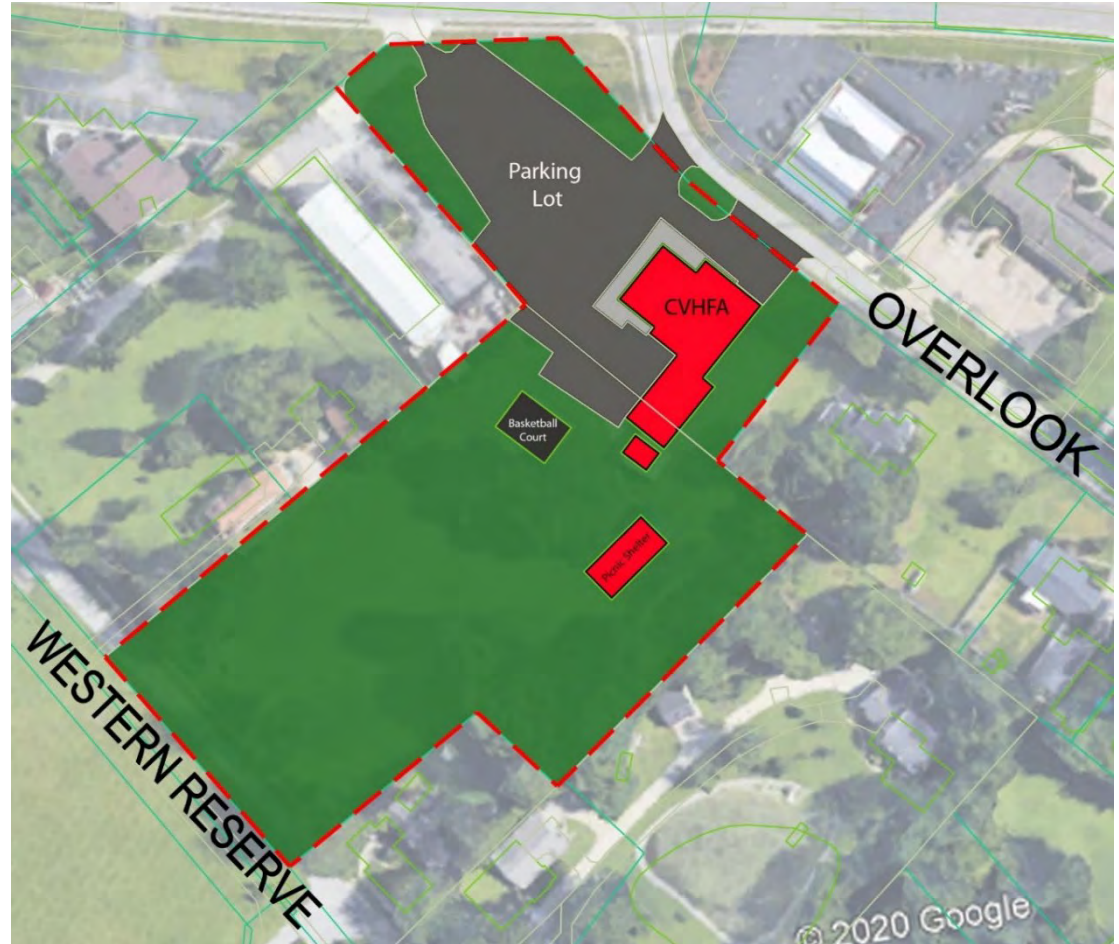
- Parking Area is a mix of several pavement types and patches. All types are in disrepair.

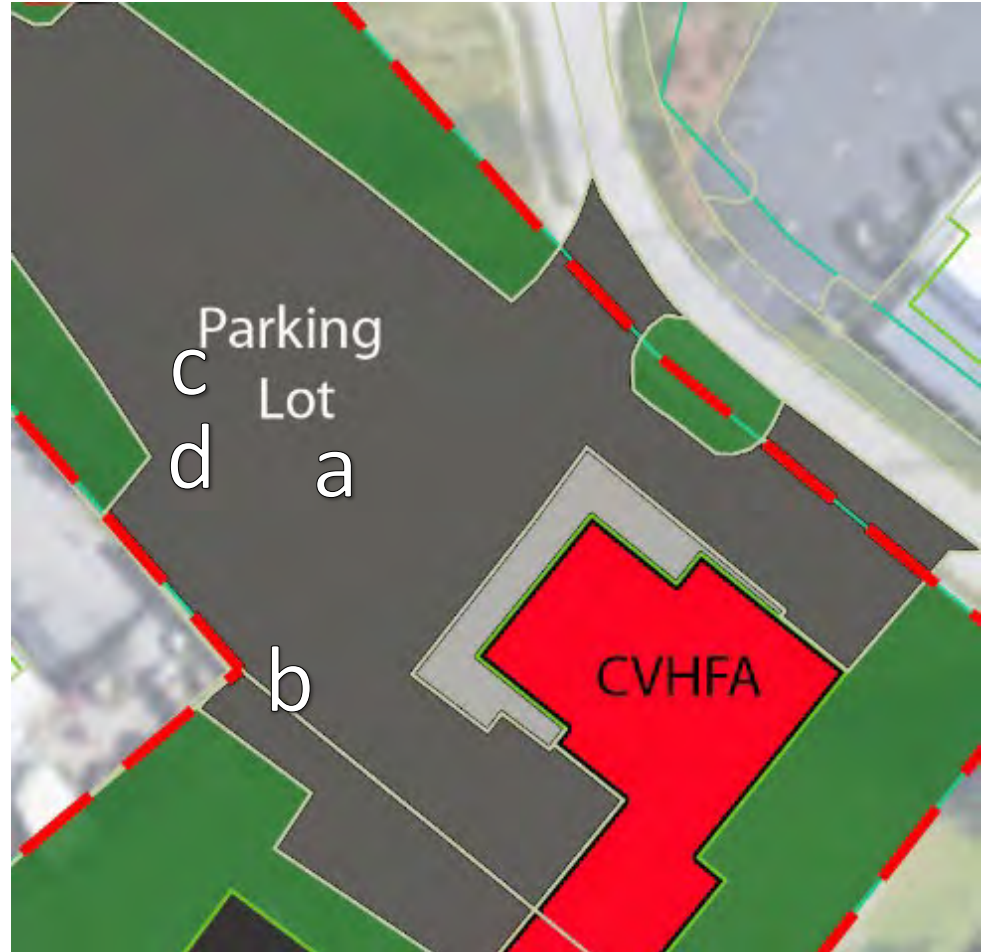
- Poured concrete in need of repairs due to expansion/contraction, corrosive salts, water intrusion, and spalling.
- Concrete failure has resulted in constant replacement of the concrete on the site resulting in a poor appearance on the exterior of the building.

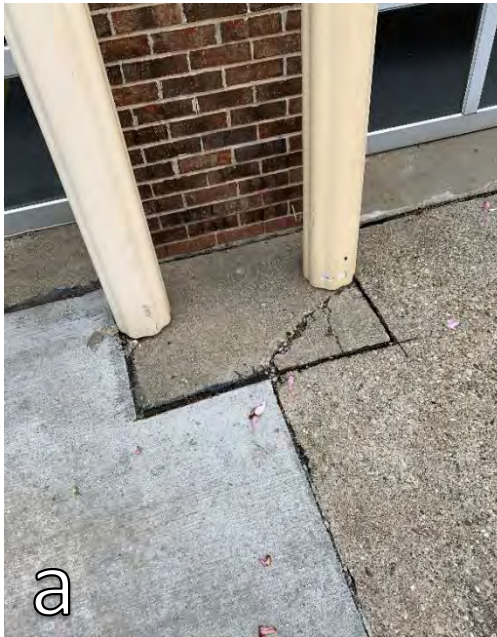
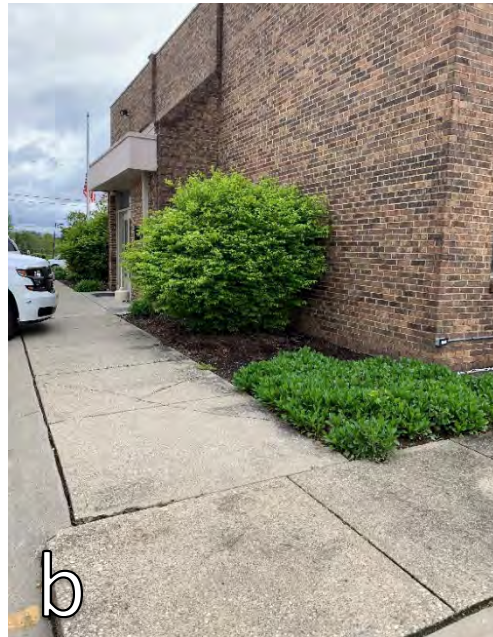
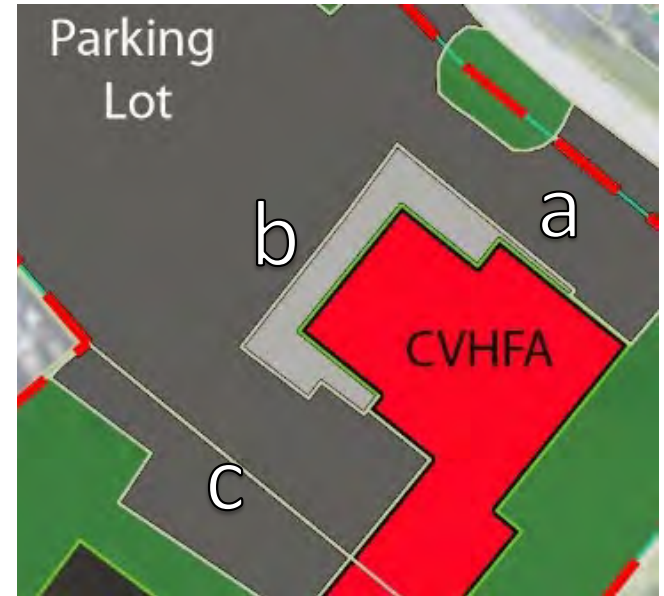
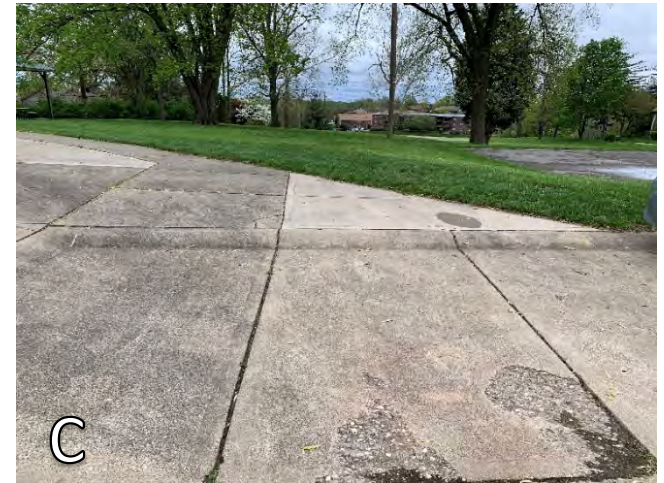
- The concrete apron at the apparatus bays needs to be replaced with heavy duty reinforced concrete designed for fire truck loading.

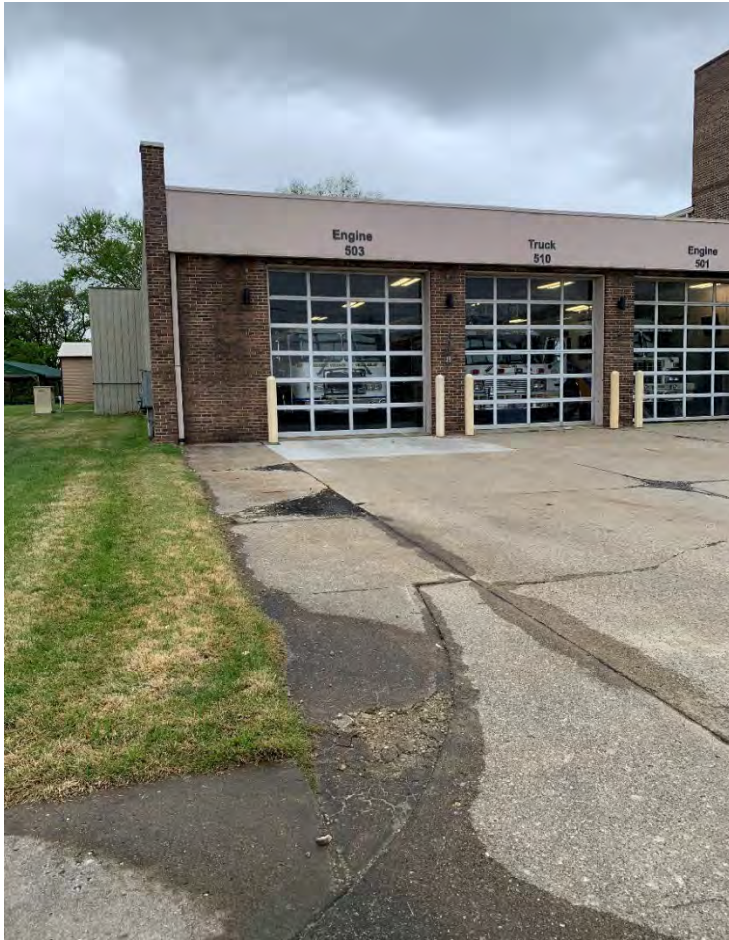
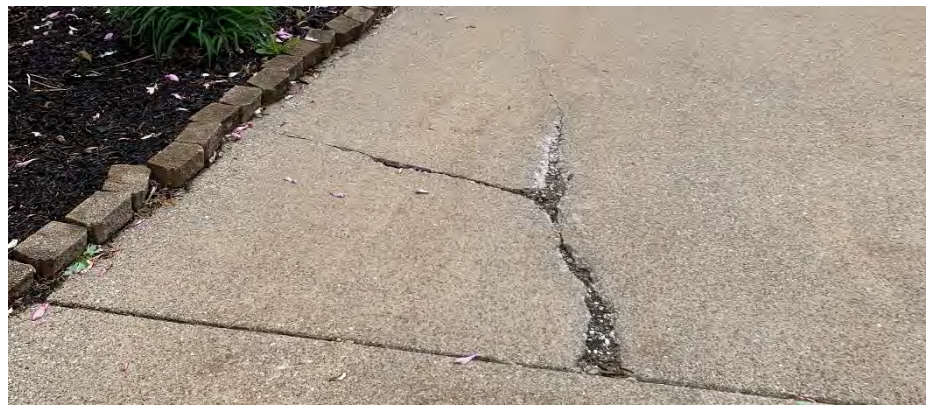
- Very few drainage structures on site and water surface flows or ponds in areas.

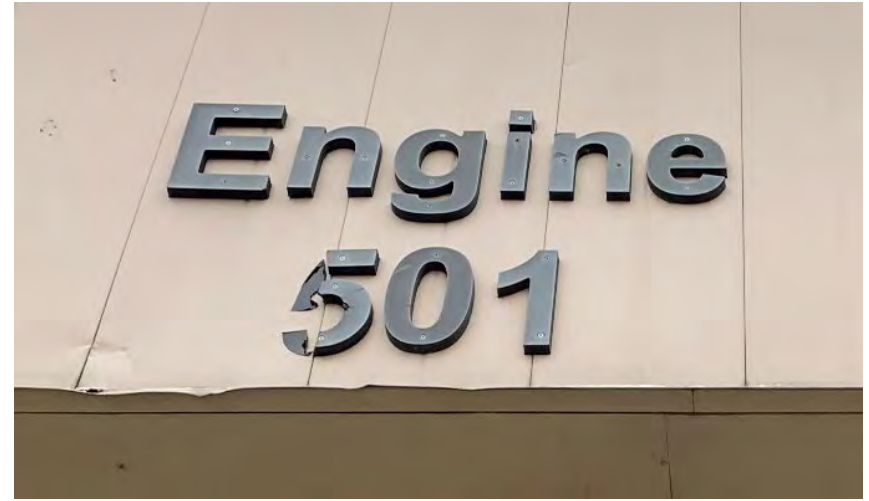
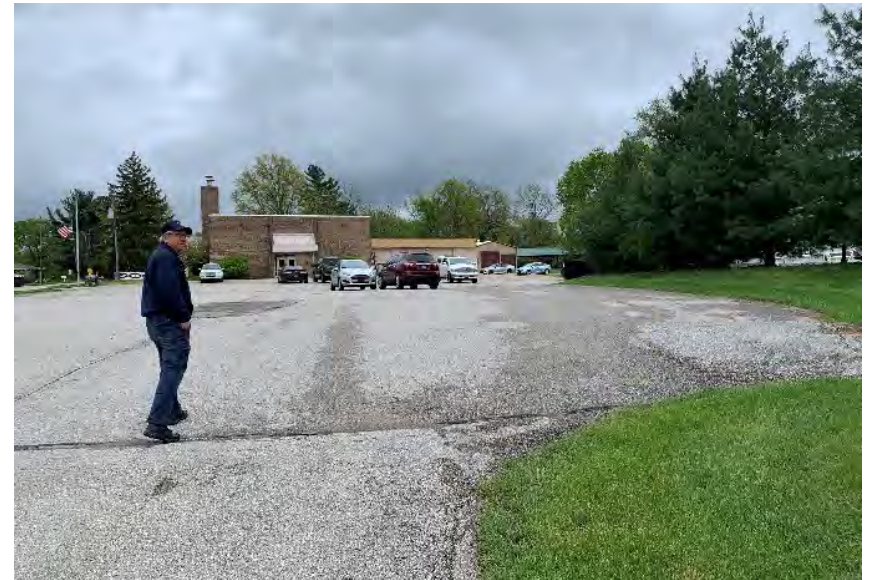
- Brick veneer needing repairs, caulking of control and expansion joints, general cleaning. Gutters are failing, rusting is occurring. Bay openings are damaged.

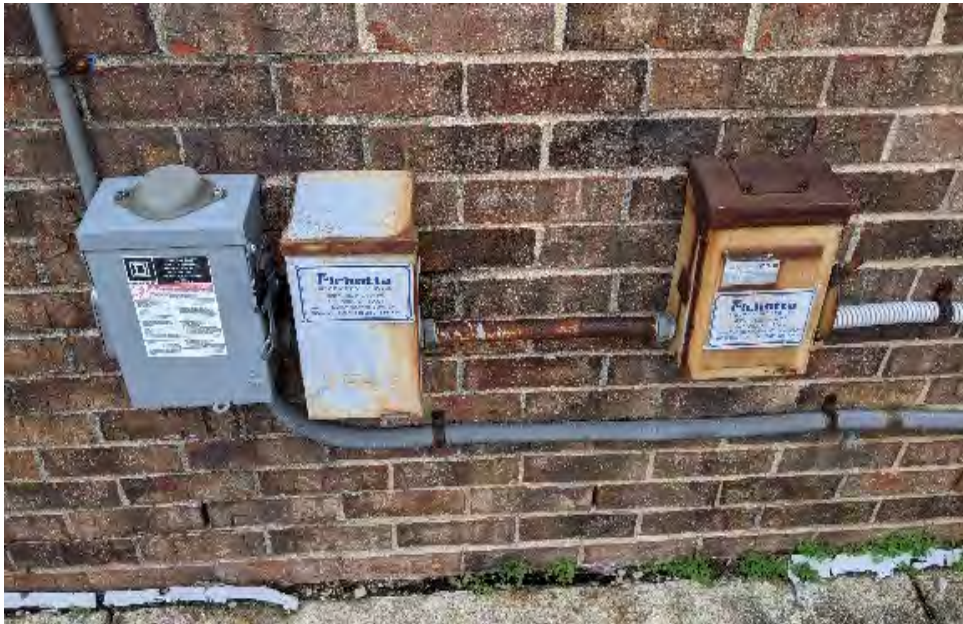
- Fairly poor condition.

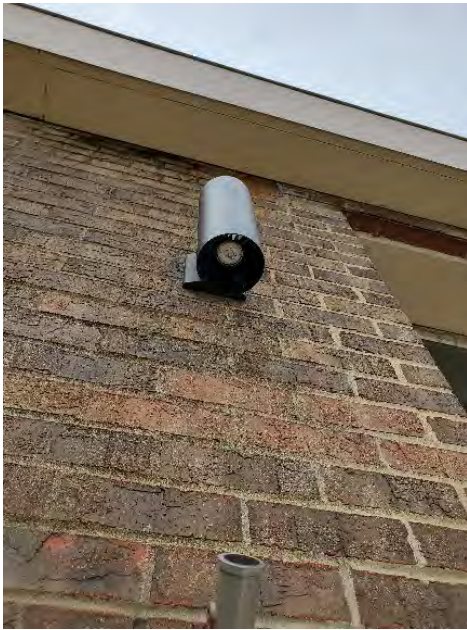
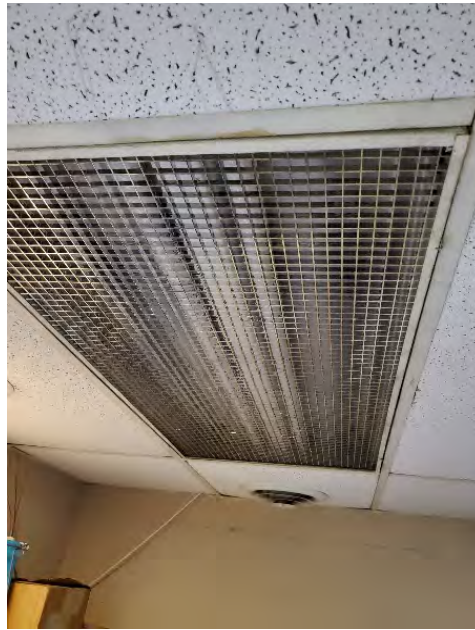
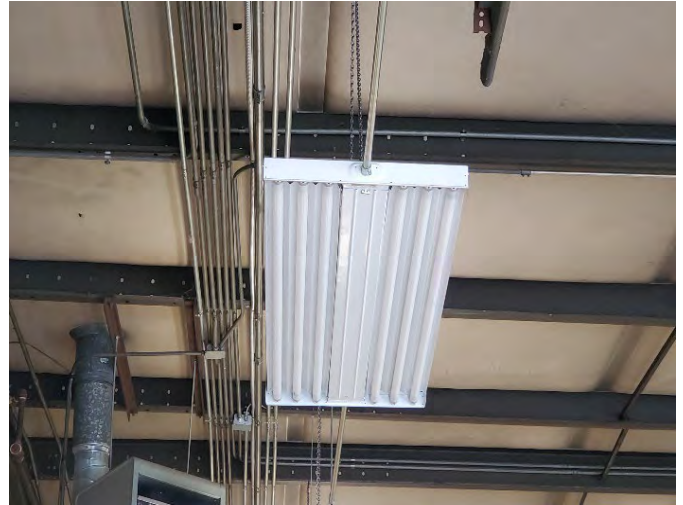
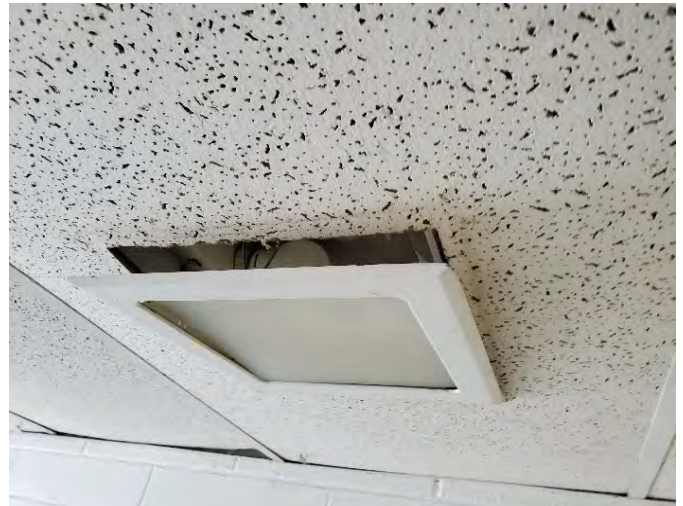
- The existing data network is in good condition.
- Staff indicated the existing sound system is in fair condition.
- Some exterior devices are showing signs of corrosion.
- Some exterior receptacles are missing the weatherproof cover.

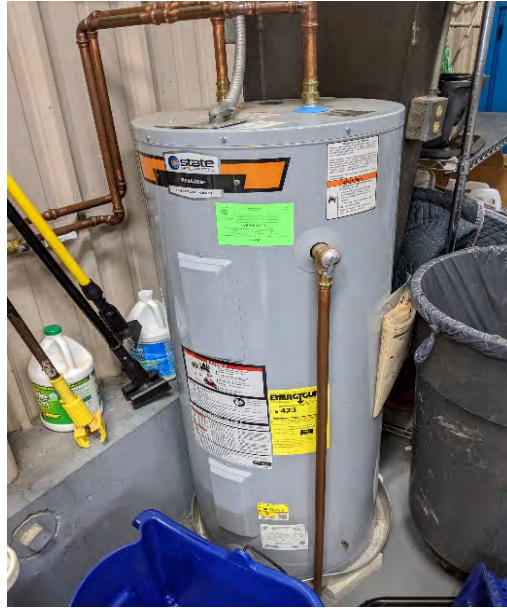
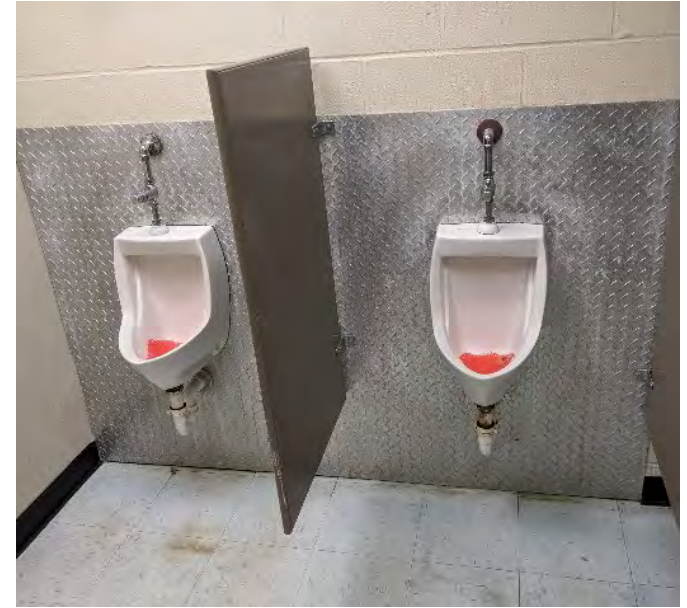
- Corrosion is occurring on plumbing system.
- Some of the plumbing pipes and valves are in bad shape and need to be replaced and repaired.
