Assessment Report
May 18, 2019

Crescent-Villa Fire Authority

Crescent Springs, KY

FACILITY CONDITION ASSESSMENT

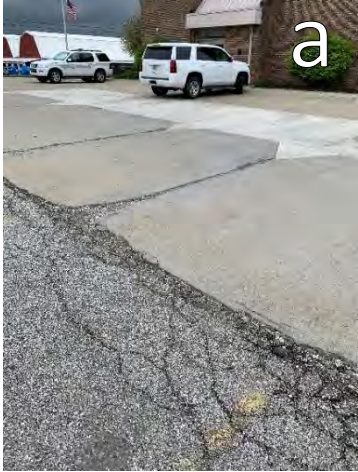
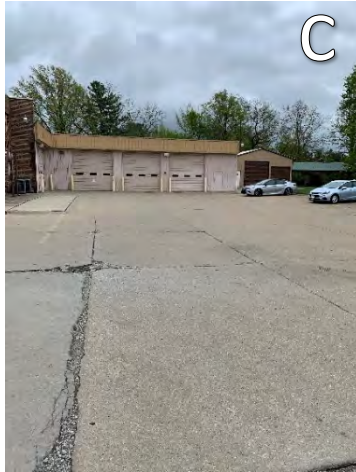
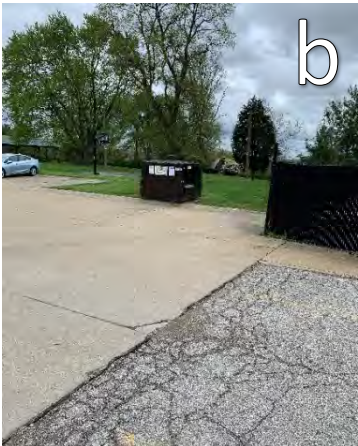
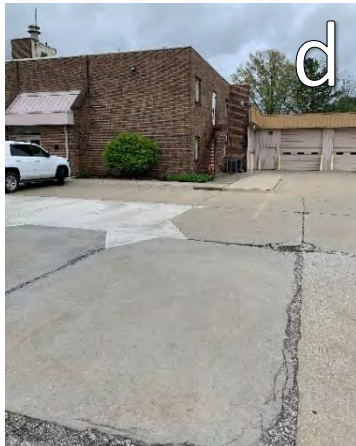
PAVEMENT CONDITION

- Parking Area is a mix of several pavement types and patches. All types are in disrepair.

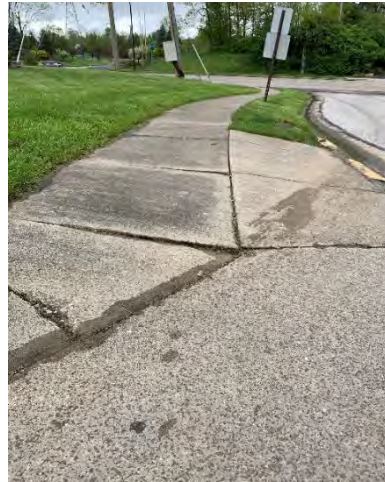
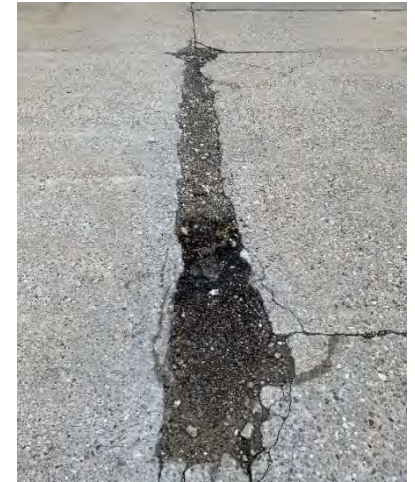
CONCRETE CONDITION

- The concrete apron at the apparatus bays needs to be replaced with heavy duty reinforced concrete designed for fire truck loading.

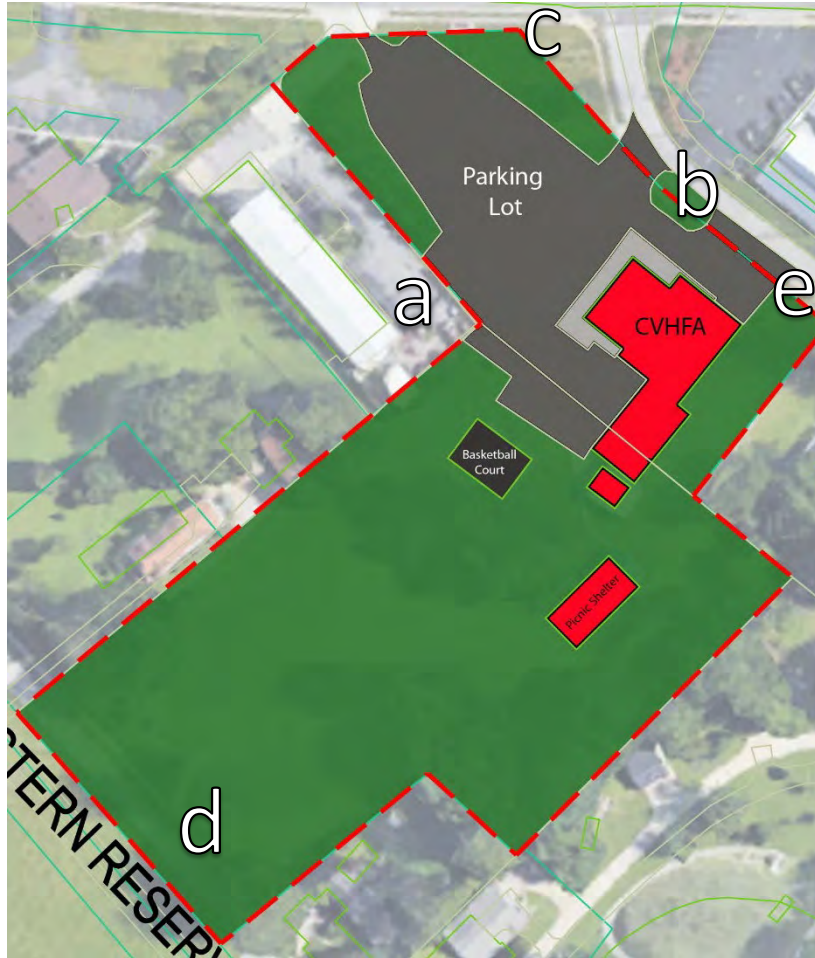
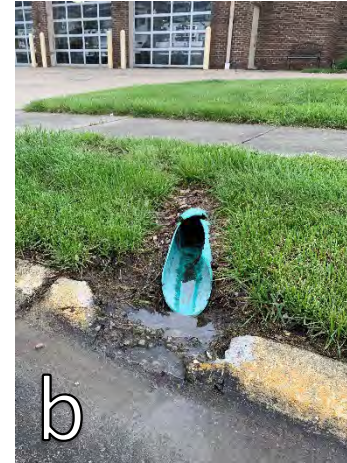
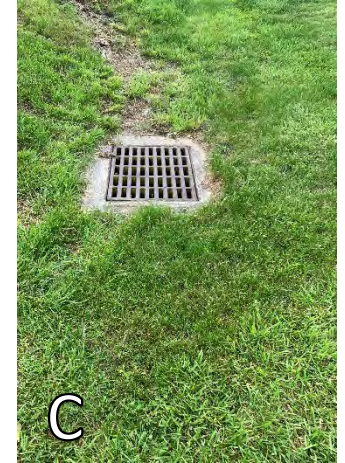
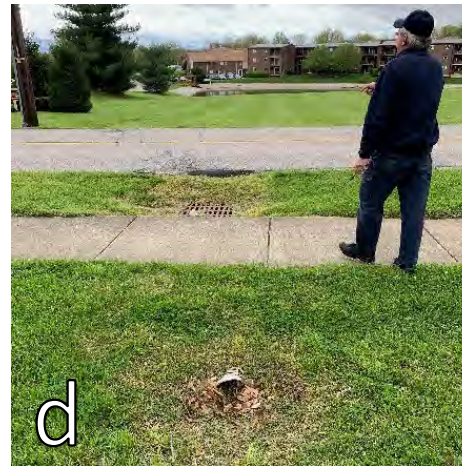
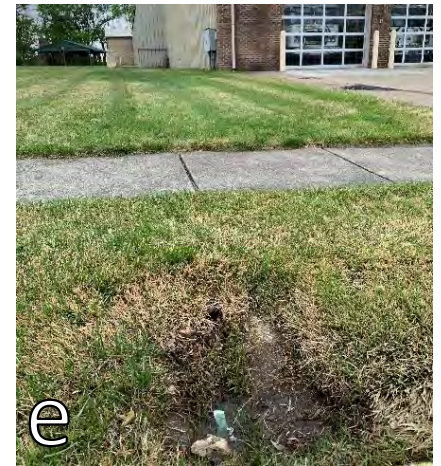
DRAINAGE ISSUES

- Very few drainage structures on site and water surface flows or ponds in areas.

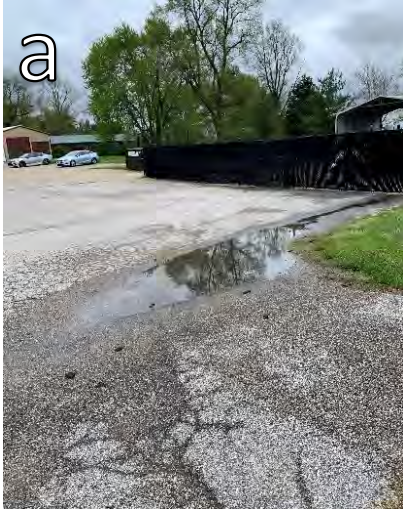
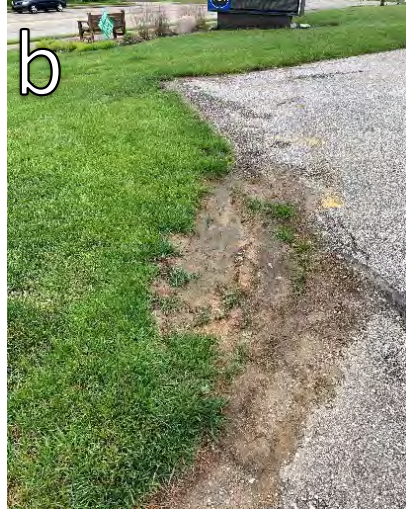
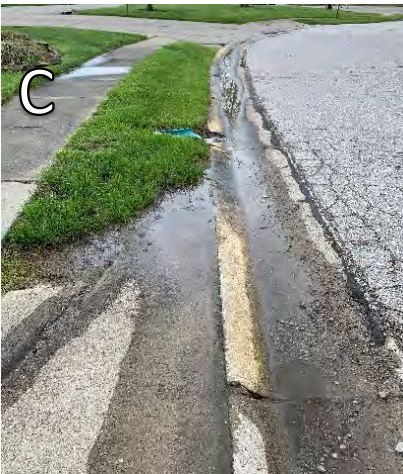
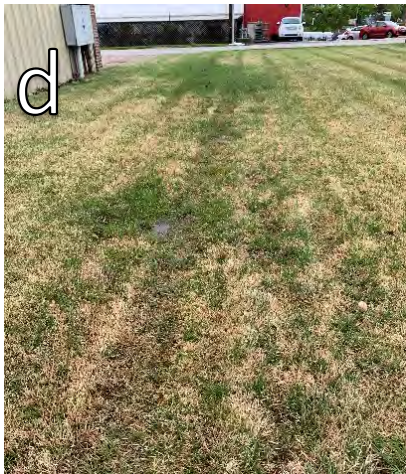
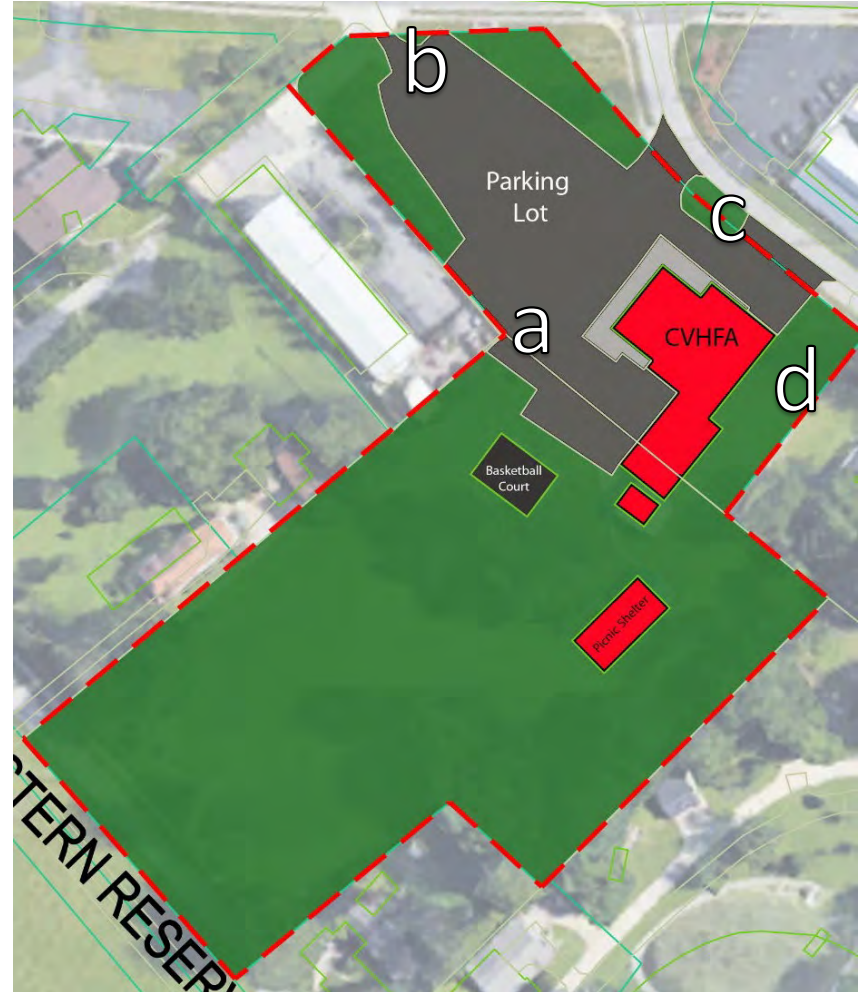
DRAINAGE ISSUES

- Several areas have standing water or are damp.

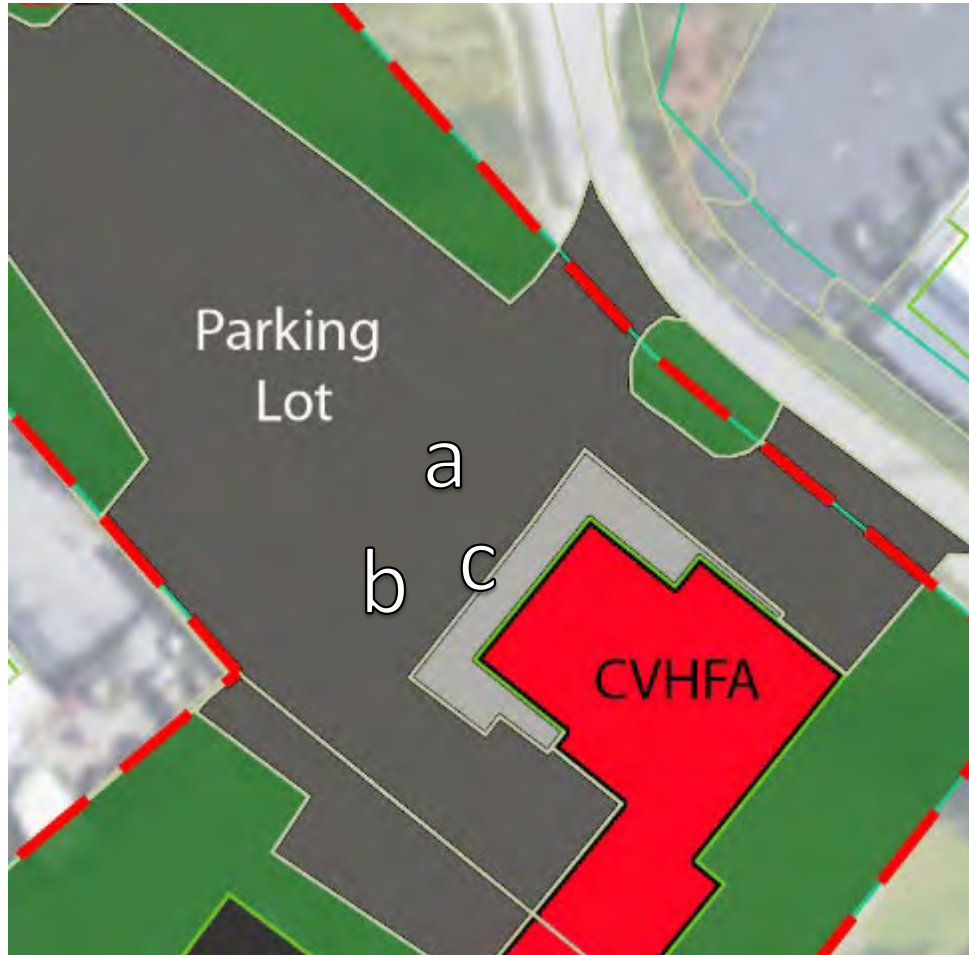
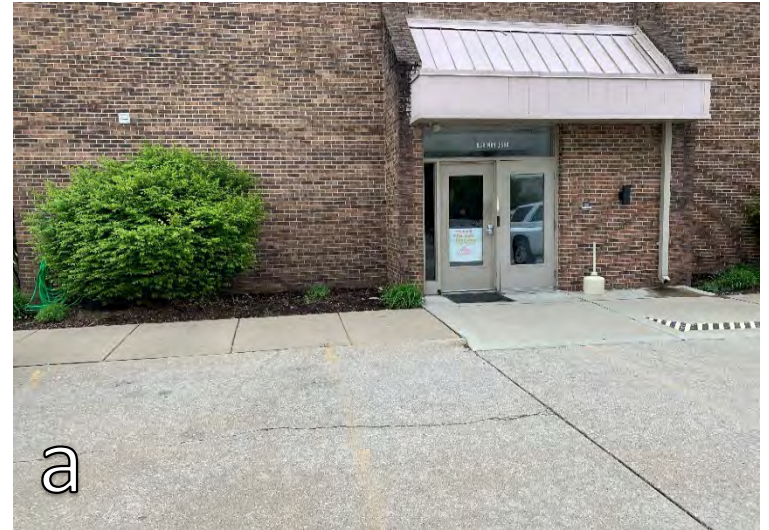
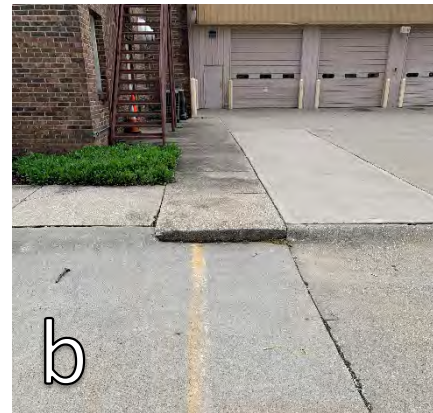
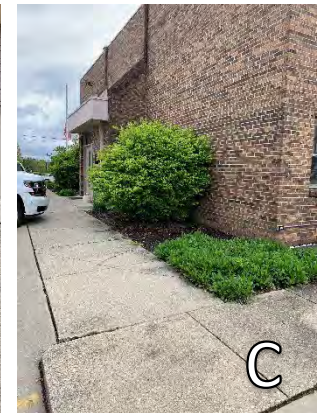
ADA COMPLIANCE

- Review ADA access and compliance issues. Designated accessible parking or ramps are not provided as required.

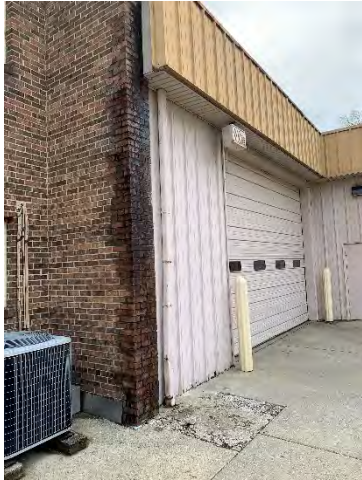
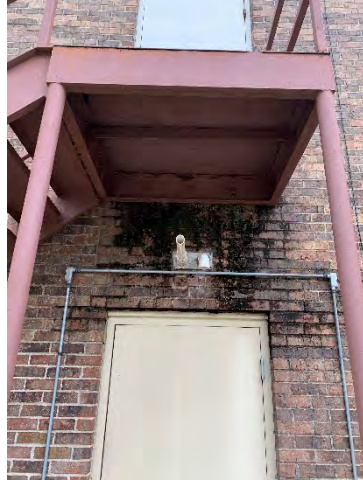
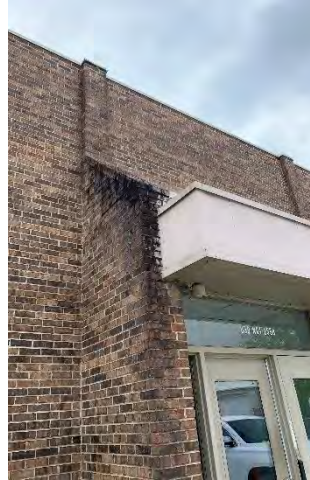
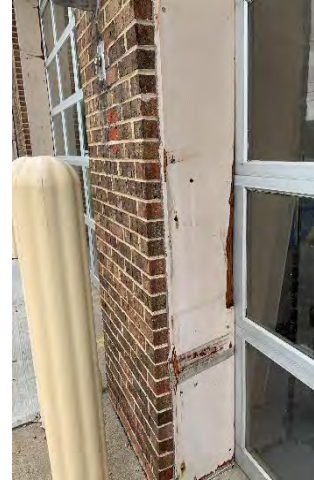
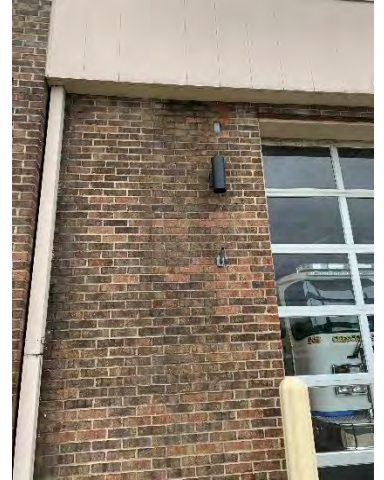
EXTERIOR WEAR

- Brick veneer needing repairs, caulking of control and expansion joints, general cleaning. Gutters are failing, rusting is occurring. Bay openings are damaged.

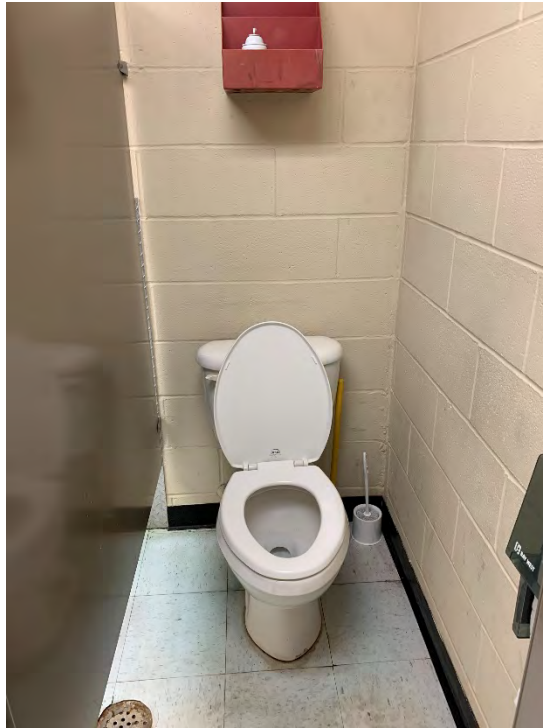
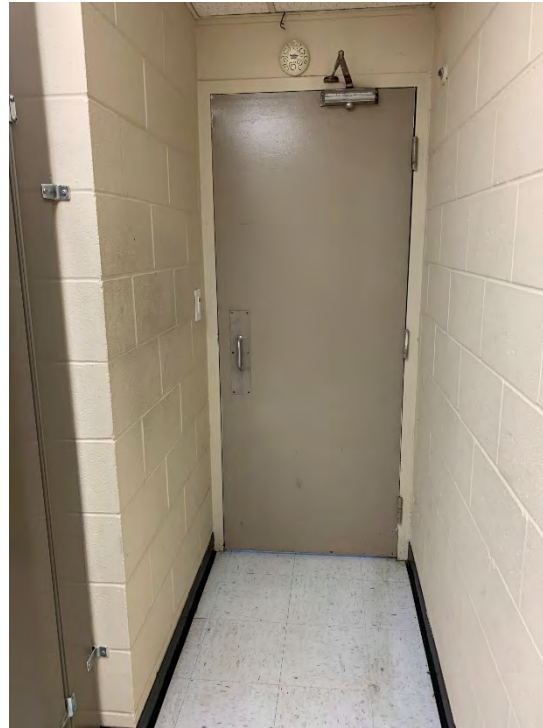
ADA COMPLIANCE

- The existing restroom access does not meet accessibility guideline clearances.
- Fixtures do not have required accessibility guideline clearances.

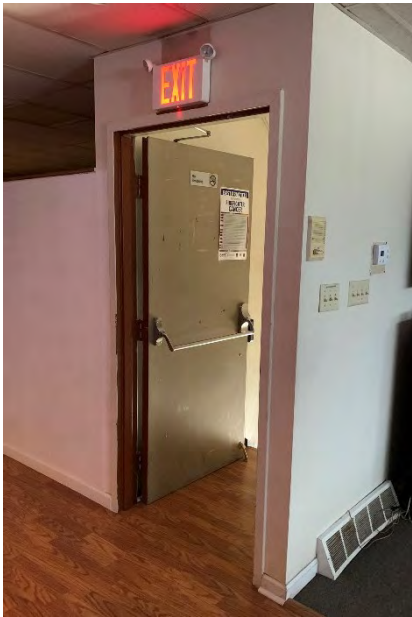
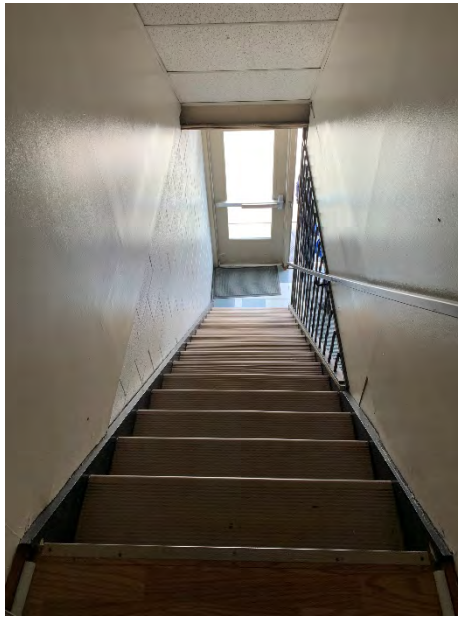
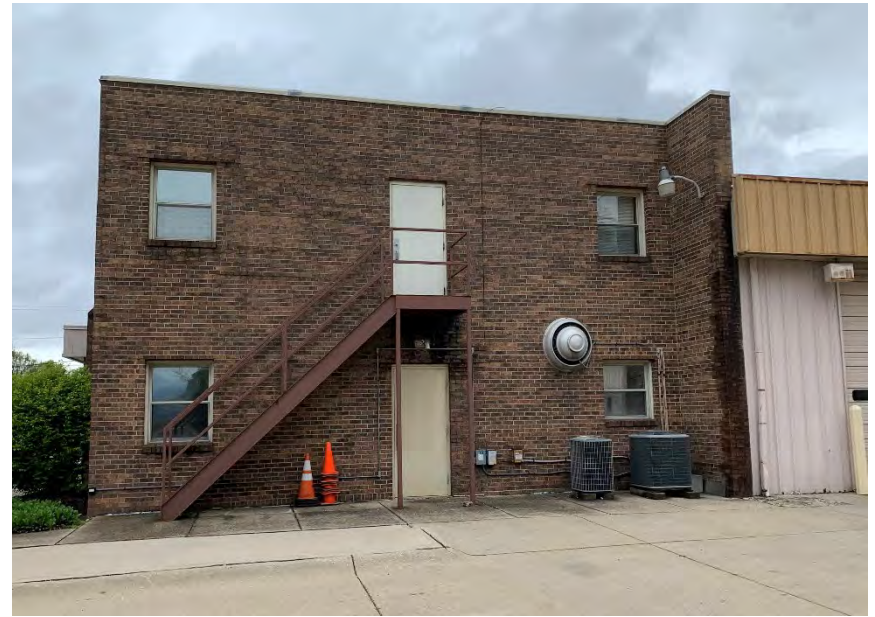
FIRE EGRESS / EXITING

- Existing exits for level 2 do not comply with current building code requirements.
- Lack of interior stair handrails and inadequate landing area.
- Inadequate landing at exterior stair and lack of weather cover.

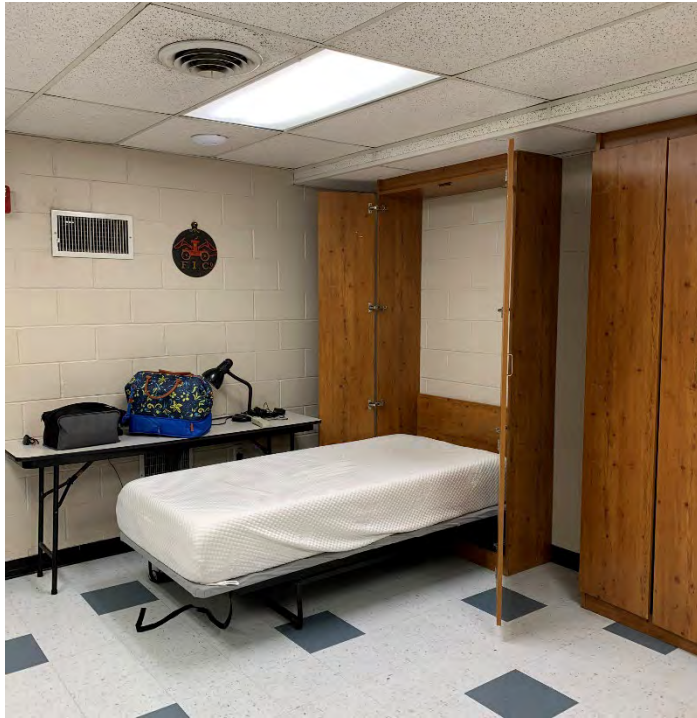
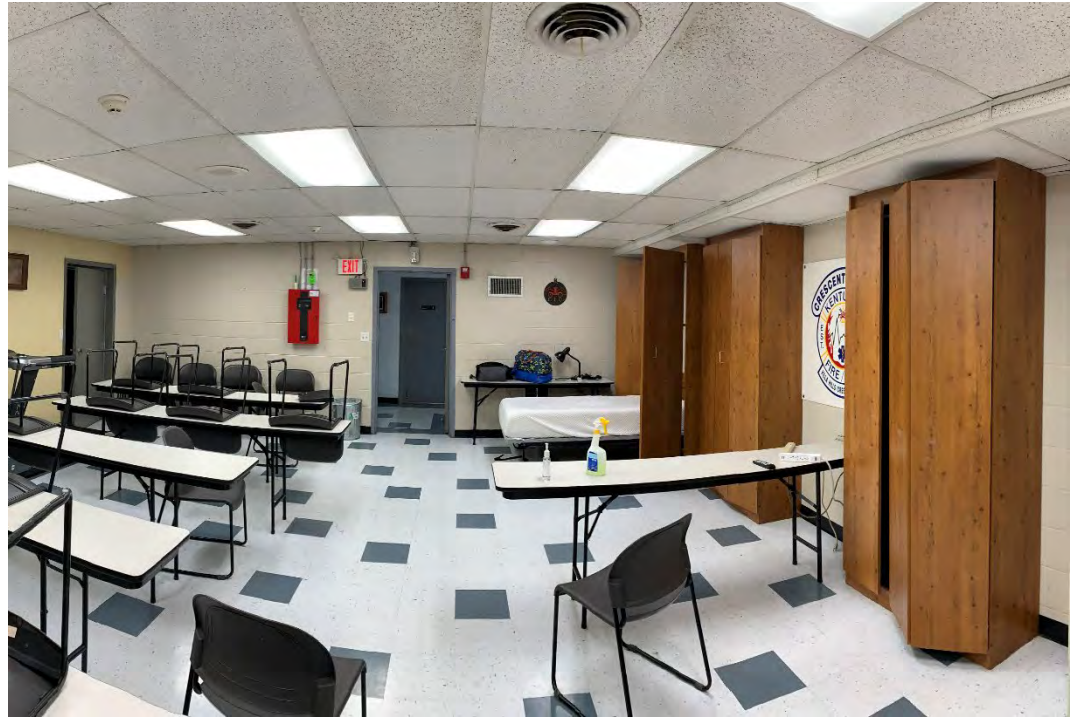
HOUSING AREAS

- Existing station is lacking in dedicated sleeping areas.
- No gender-specific sleeping or shower areas.
- No private lactation space provided.

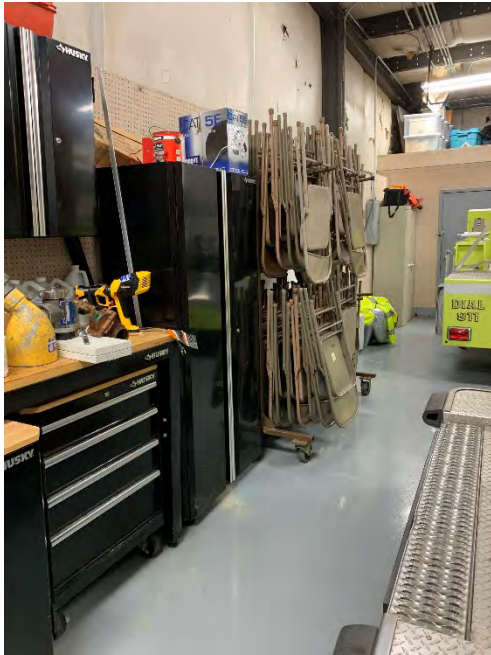
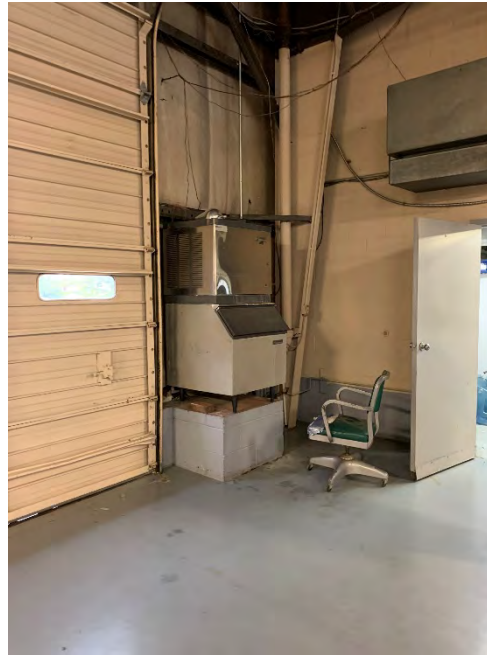
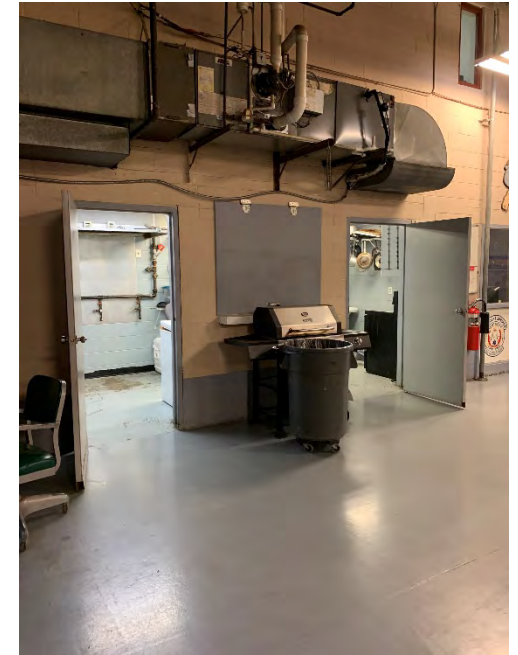
DECONTAMINATION

The existing facility has poor decontamination systems in place.

- Lack of physical separation between possible contamination of apparatus bay (hot zone) and firehouse (cold zone).
- Lack of HVAC / other systems to support HOT / COLD separation.
- Insufficient personal shower facilities.

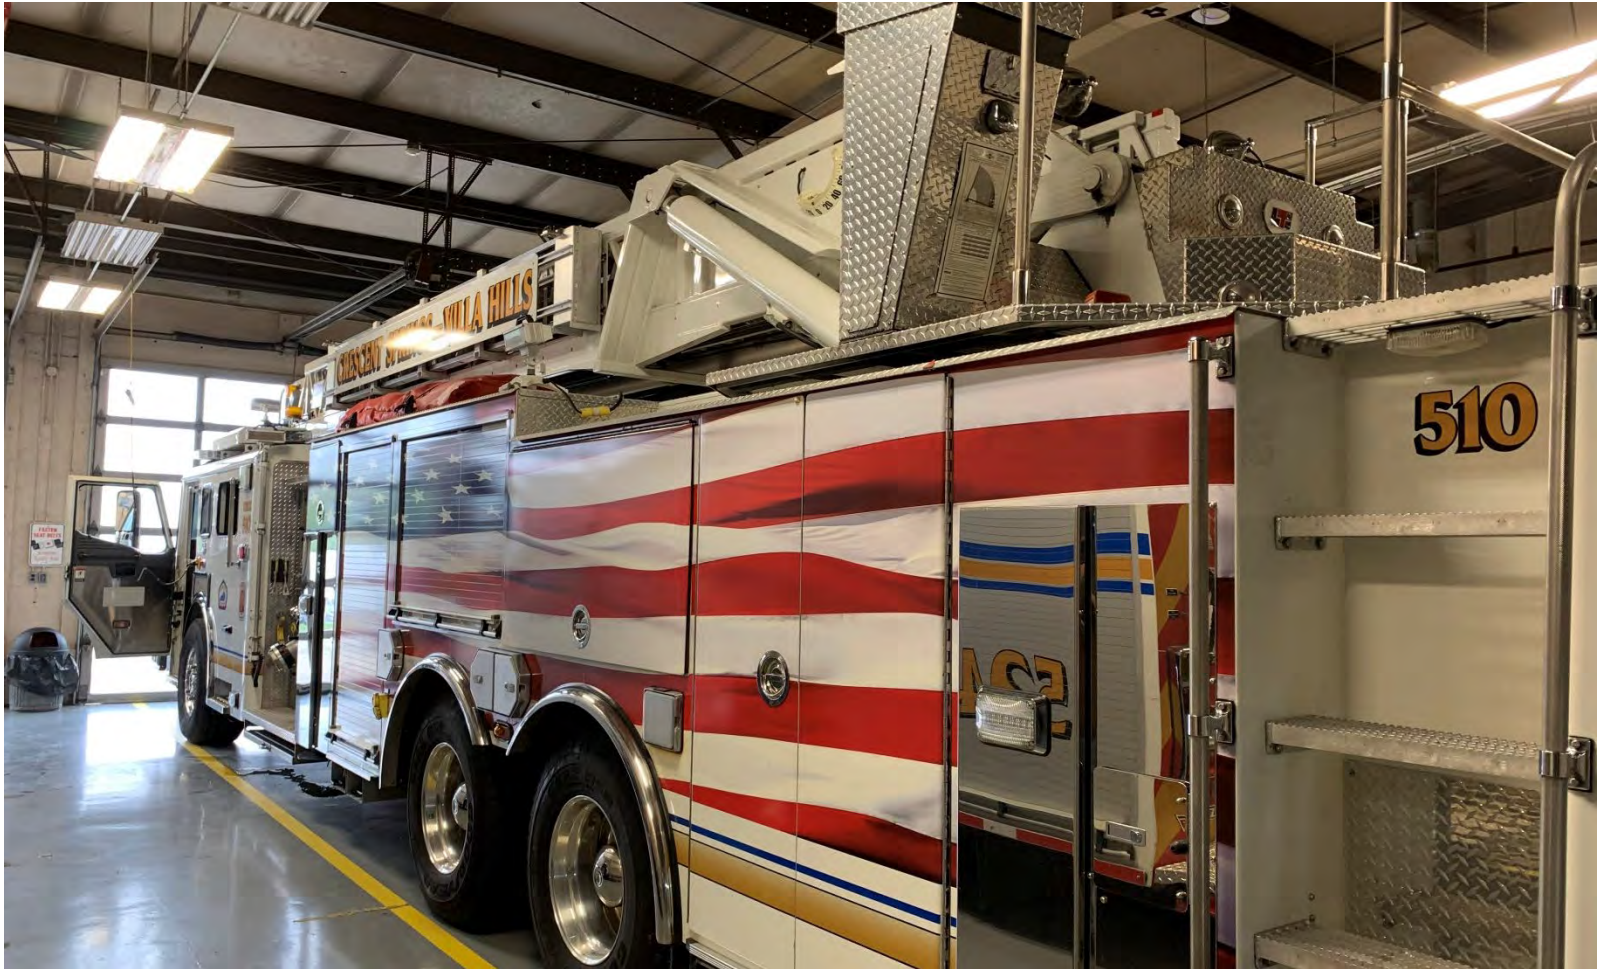
DECONTAMINATION

- No direct or source exhaust capture system.

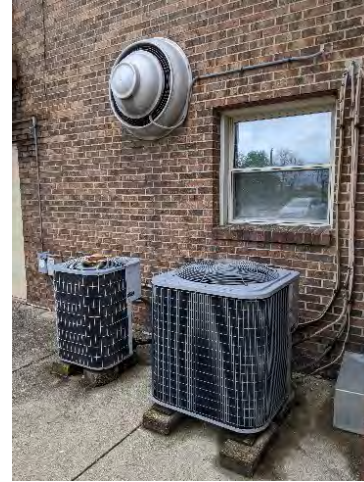
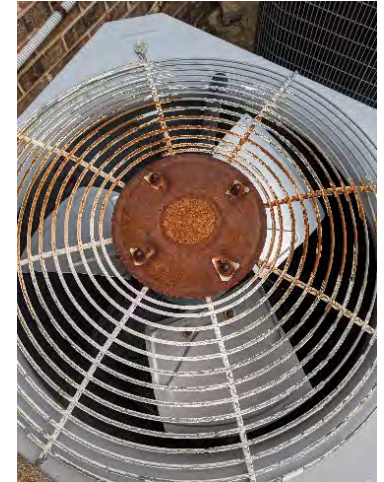
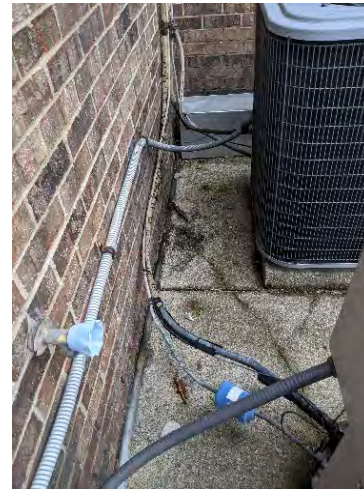
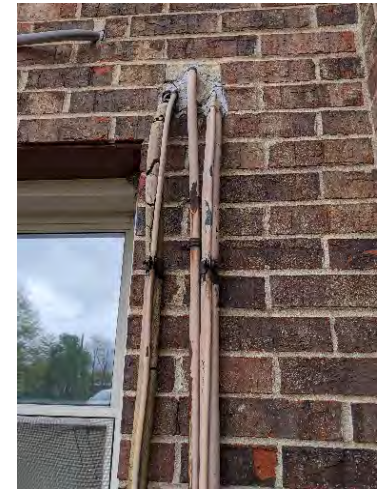
HEATING / COOLING

- There are two Carrier 4-ton air cooled condensing units outside on 2x4s.
- One 2005 and another one 2011 unit.
- Refrigeration lines and insulation appear in poor condition.
- Breaker in poor condition.

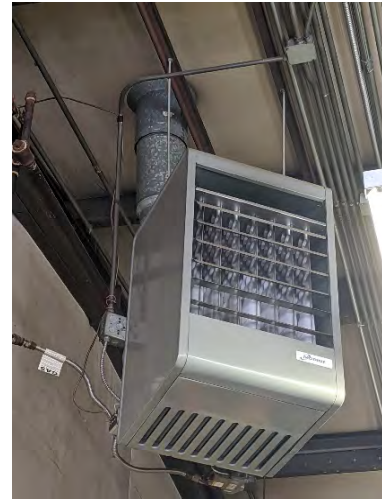
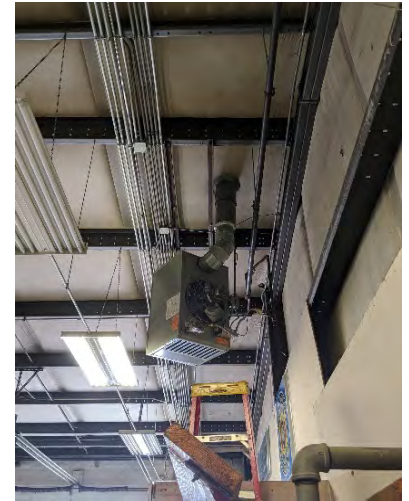
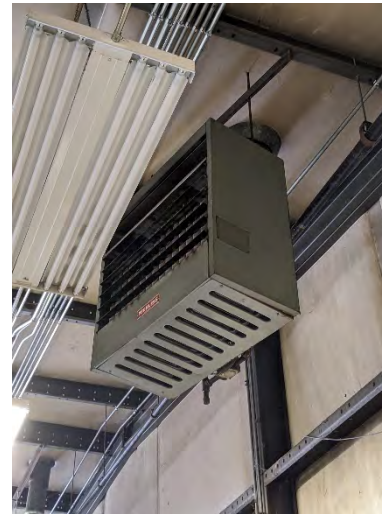
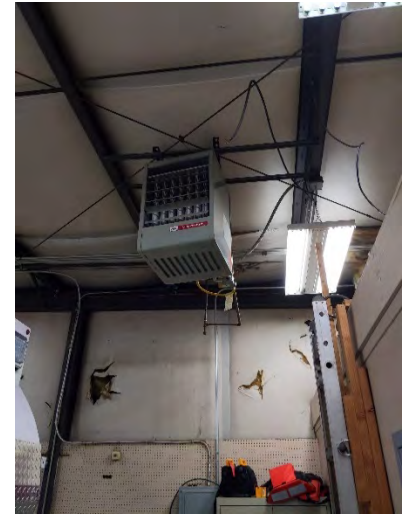
APPARATUS BAY HEATERS

- Gas unit heater in various stages of condition.

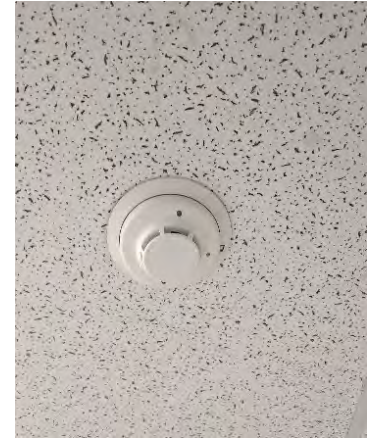
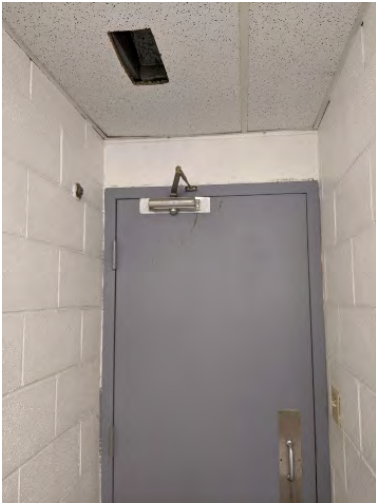
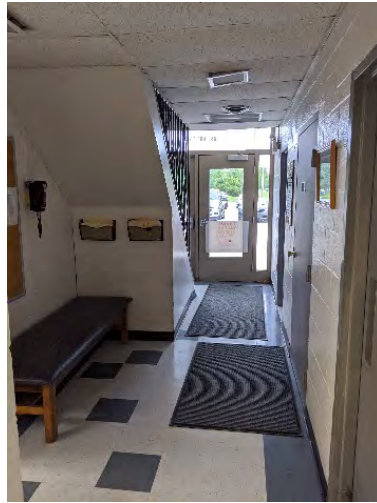
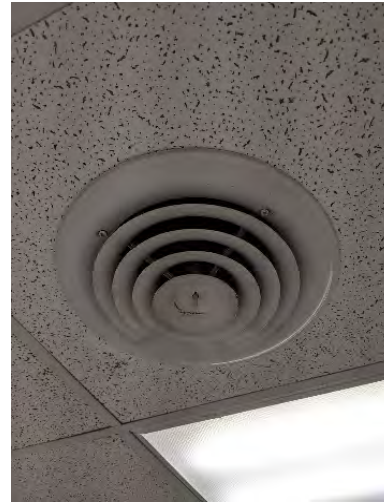
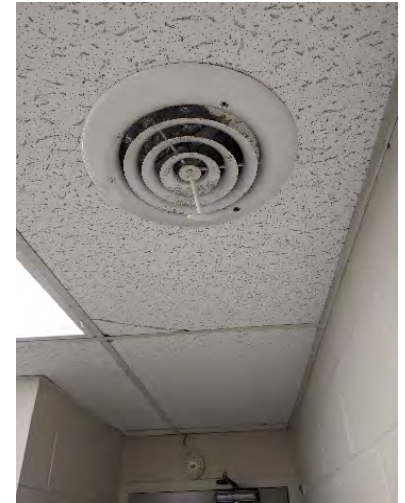
CEILING AIR DEVICES

- Ceiling air device in poor condition.

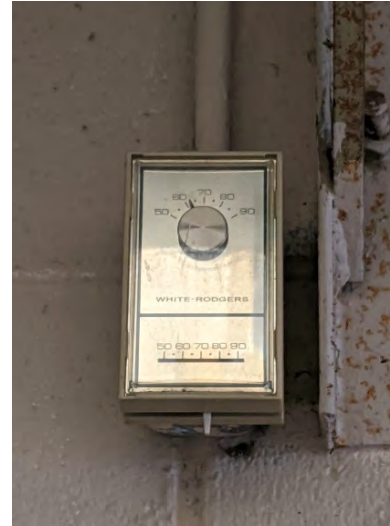
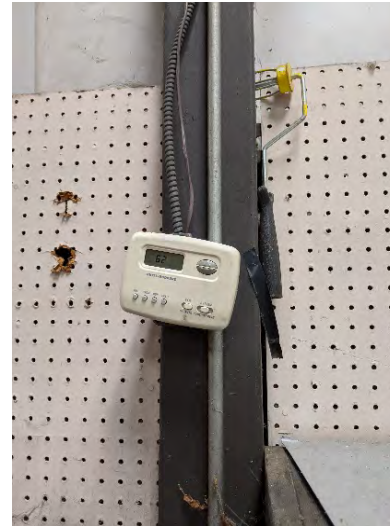
HVAC CONTROLS

- Wall thermostats in poor condition.

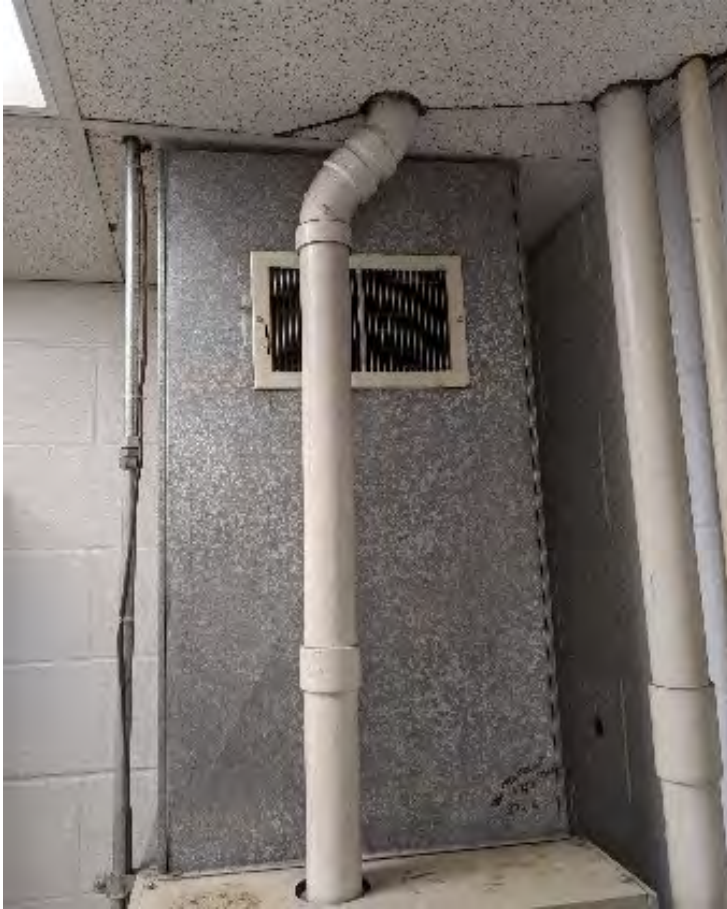
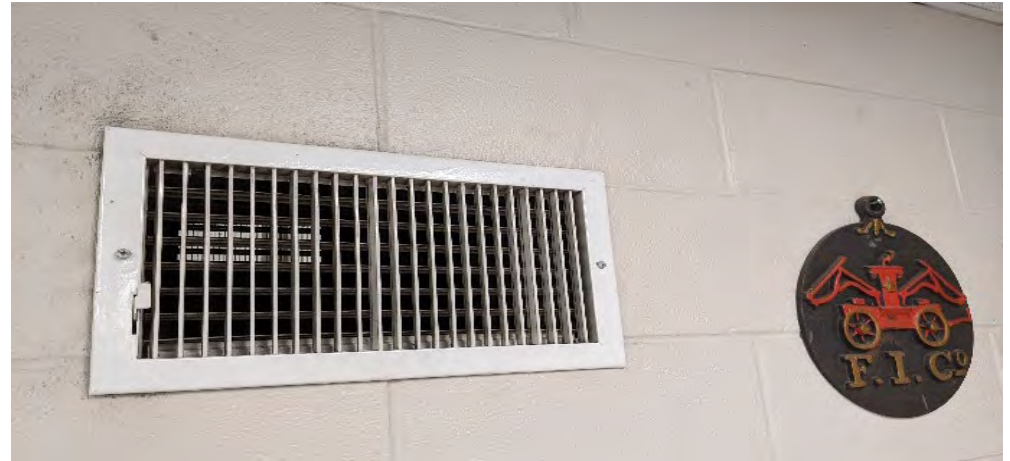
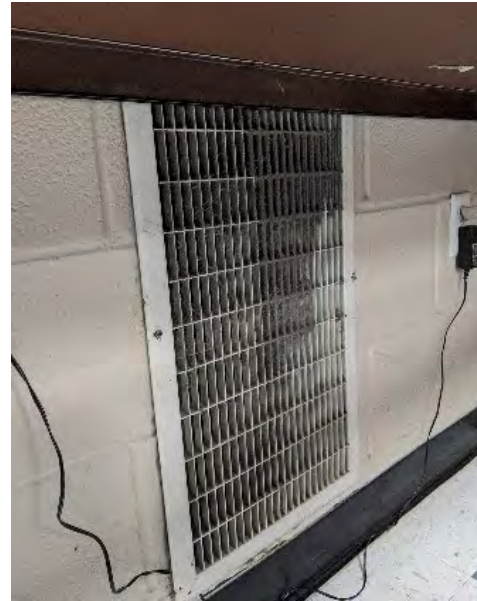
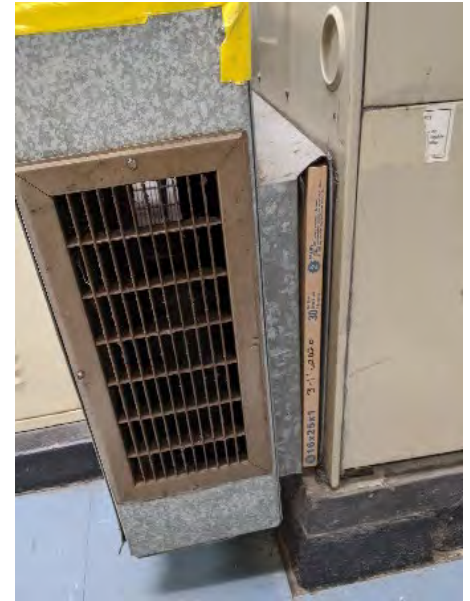
HVAC REGISTERS / GRILLES

- HVAC wall registers and grilles in poor condition.

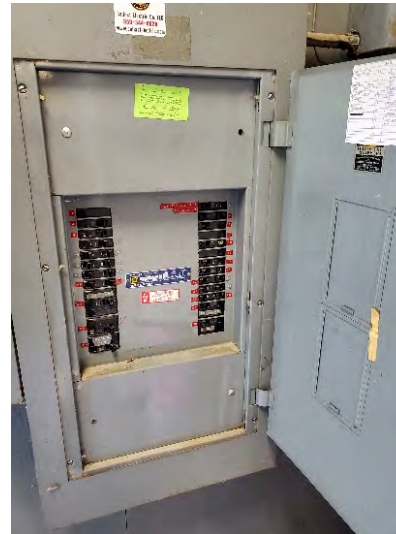
- The existing Square D main service disconnect switch in good condition. The switch is rated 400A, 240Vac, 3-phase. The Owner indicated they have to unplug one piece of equipment to run another.
- The existing Square D Type NQO main panelboard is in good condition. The panel is rated 400A, 120/208V, 3-phase, 4-wire.
- The existing subpanel load center is currently maxed out. The panel has space for 24 circuits, but currently has 28 breakers. The load center currently does not have the code required clearance.

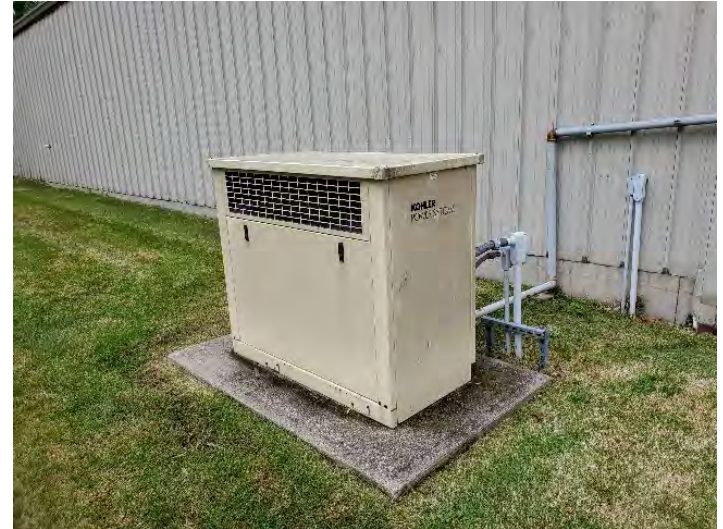
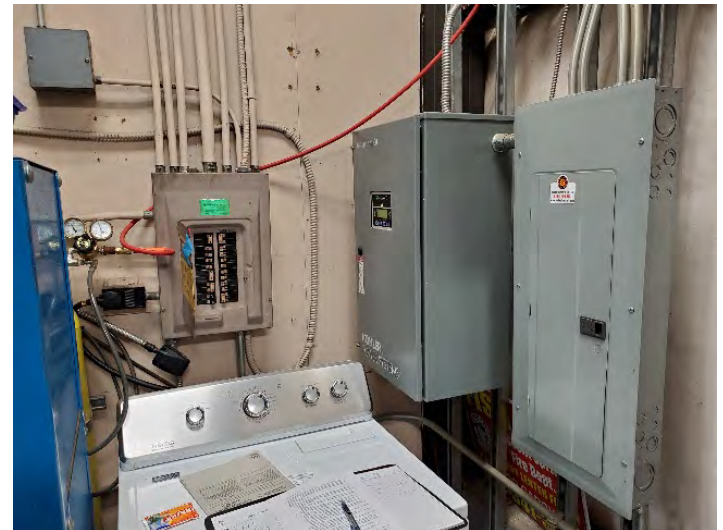
- The existing Kohler 25KW natural gas generator is in good condition. Staff noted the unit is under a service contract to be tested and maintained. Staff noted the unit is approximately 14 years old.
- The existing Kohler automatic transfer switch is in good condition. The switch is tested and maintained by the generator service contract.
- The existing Cutler-Hammer emergency distribution panel is in good condition. The panel is rated 200A, 120/208V, 3-phase, 4-wire.
- The Kohler automatic transfer switch and Cutler-Hammer emergency distribution panel currently do not have the proper code required clearances.

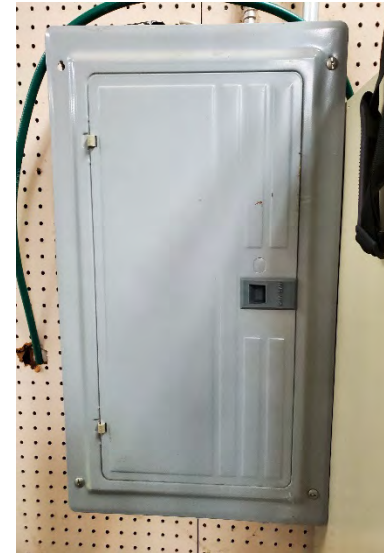
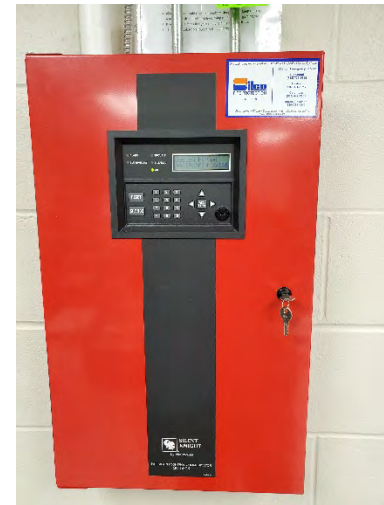
- The existing addition Siemens panel is in good condition. The panel is rated 125A, 120/208V, 1-phase, 3-wire.
- The existing Silent Knight fire alarm panel is in good condition. Staff noted the system has been installed for approximately 5 years.
- Staff noted the antenna and radio system are due for an upgrade. They noted a project is in the works to replace them.
- Staff noted the existing branch circuit wiring is a mix of wire types, noting they used whatever was on hand.

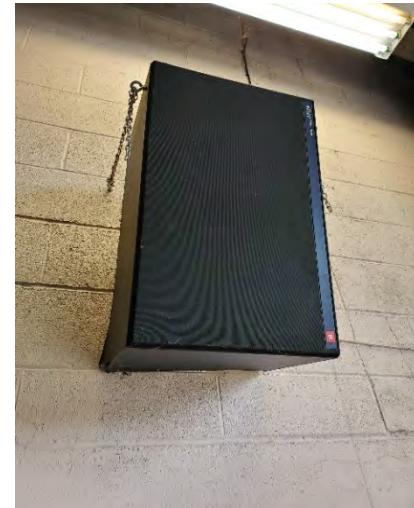
- The existing data network is in good condition.
- Staff indicated the existing sound system is in fair condition.
- Some exterior devices are showing signs of corrosion.
- Some exterior receptacles are missing the weatherproof cover.

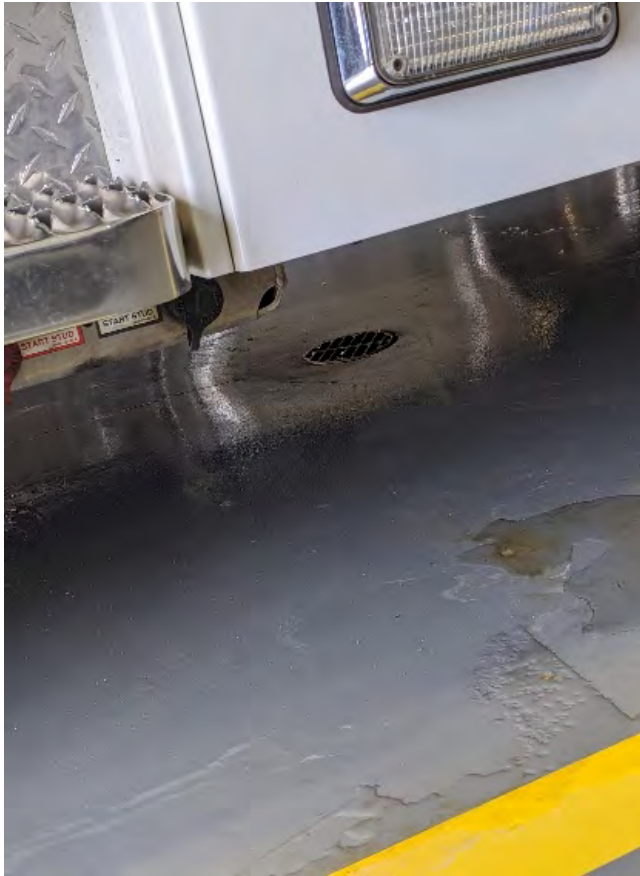
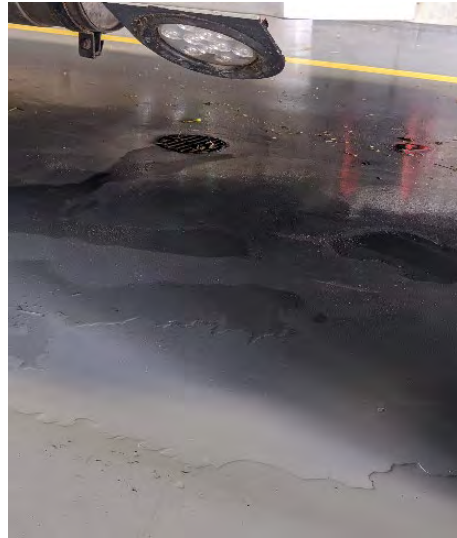
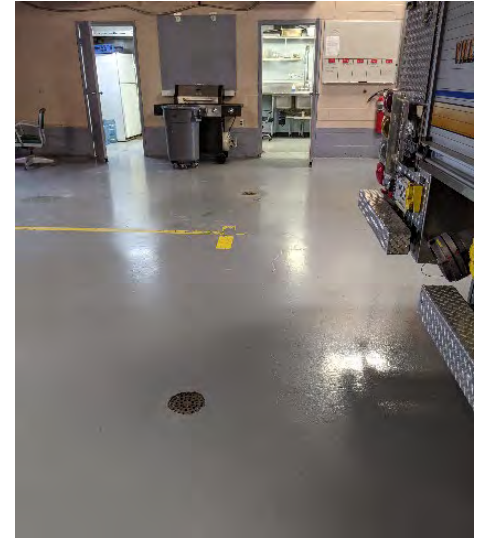
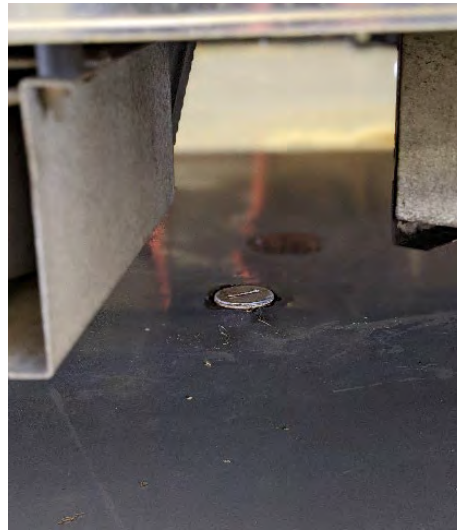
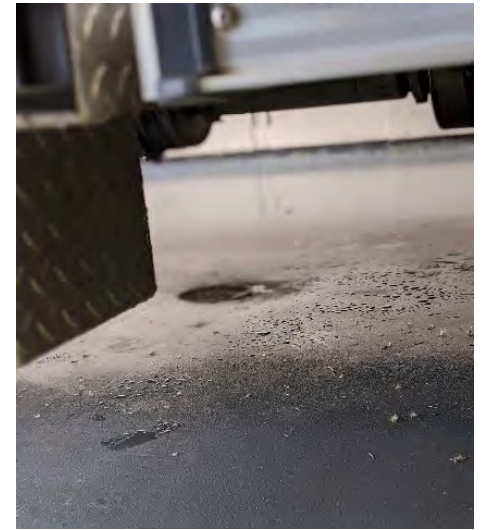
- Apparatus bay drainage is insufficient, allowing water to build up.

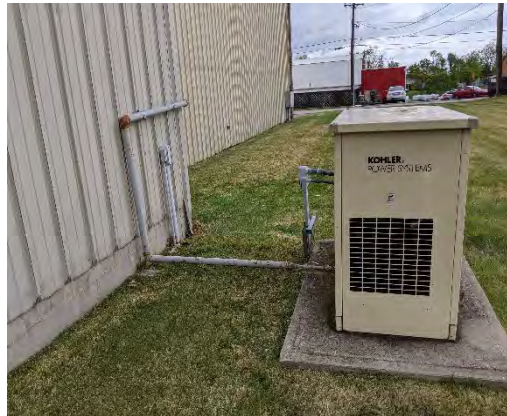
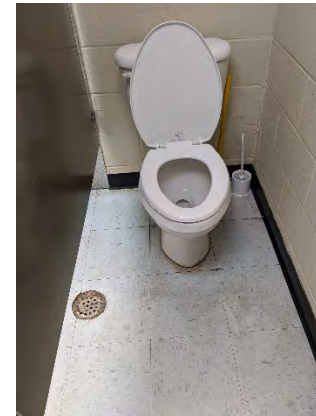
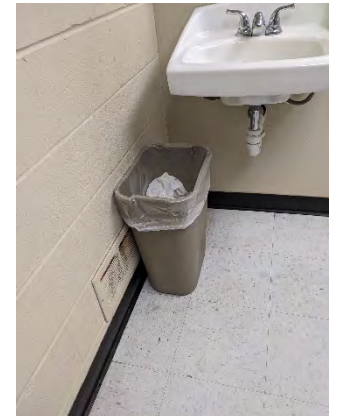
- The building's hot water system is served by a 40 gallon electric water heater.
- Toilet plumbing fixtures are in fair condition.
- The emergency generator's gas line is in poor condition.
