Assessment Report
May 18, 2019

Crescent-Villa Fire Authority

Crescent Springs, KY

FACILITY CONDITION ASSESSMENT

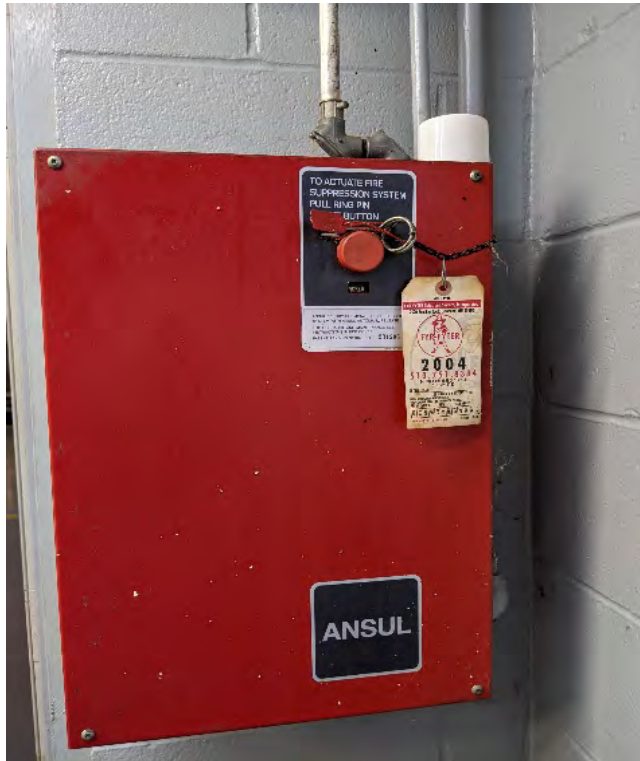
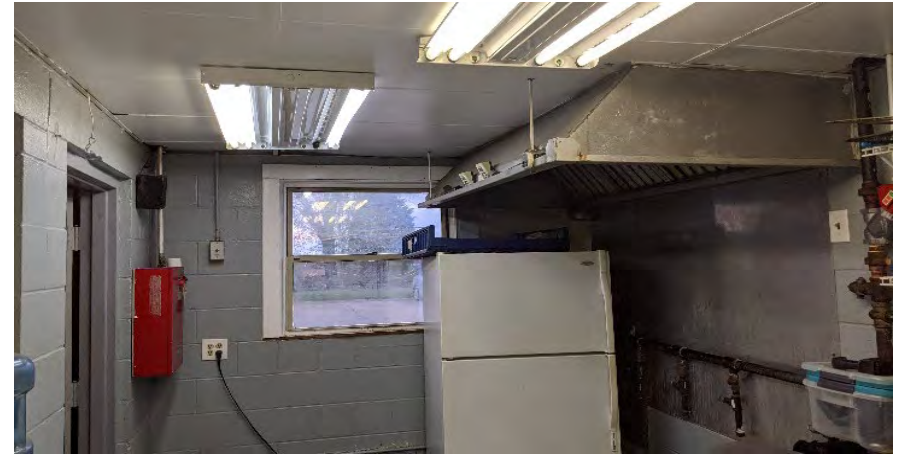
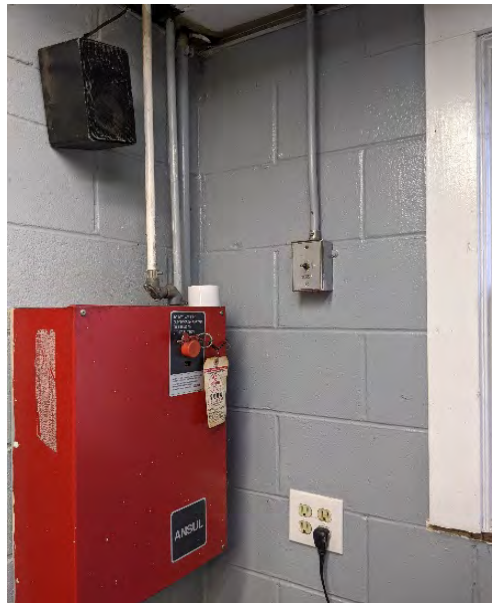
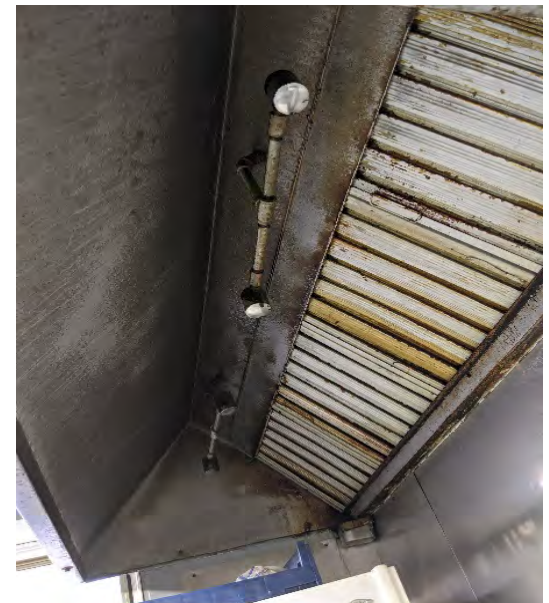
- The facility is not sprinklered.
- Kitchen hood has a dry chemical fire suppression system with Ansul automatic release dated 2004.
